## Atraumatic Breakage of a 4<sup>th</sup> Generation BIOLOX Delta Ceramic Head in Total Hip Replacement: A Case Report

**Keywords:** Ceramic head failure in THR

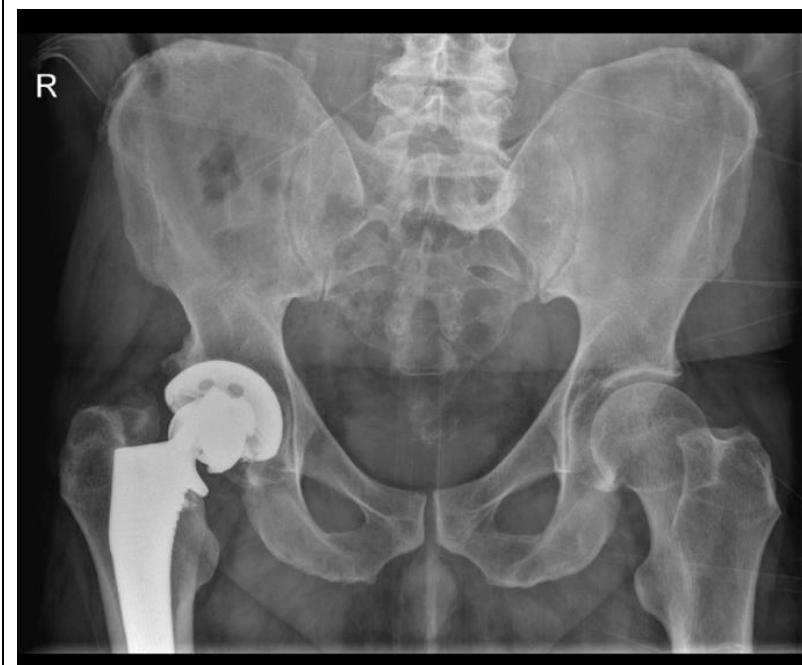
Based on anamnesis and clinical examination, a fracture of the prosthetic femoral head was suspected. Radiographic evaluation of the pelvis and right hip was carried out to support the working diagnosis. This showed abnormal alignment of the prosthetic femoral head and stem, with the dislocated prosthetic head impacted between the femoral stem and the acetabular cup, both of which appeared intact without any signs of failure. The remainder of the pelvic region appeared normal, except for degenerative changes in the left sacroiliac joint and lower lumbar spine. Along with the pelvic X-ray, a thoracic radiograph was performed, showing no clinical abnormalities. A standard blood work test was performed and showed no abnormalities. Due to limited experience with this type of material, revision surgery could not be performed at this hospital. Therefore, following initial first aid, the patient was transferred to hospital where the primary surgery had been carried out three years prior.

**Figure 3:** X-ray at the ER department showing destruction of the femoral head.

A revision surgery was performed to reconstruct the hip joint anatomy. This surgery was performed by Hans Feyen and Brecht Schuermans. The patient was placed in a supine position, and a time-out procedure was conducted. Both lower extremities were disinfected with Braunoderm (povidone-iodine/alcohol solution) from the waist down and covered with sterile drapes. The former direct anterior approach was re-utilized. Upon entering the joint space, severe fibrosis of the hip joint capsule was observed and extensively resected. Cultures were obtained from both the joint capsule and fluid, which appeared negative after microbiological examination. Opening the joint capsule revealed a multifragmented fracture of the femoral head as well as significant damage to the femoral taper and acetabular liner. Fracture fragments were carefully removed, along with the taper and liner, followed by a thorough irrigation of the hip joint. The damaged taper was initially protected with a plastic sleeve, after which a new 58 mm acetabular liner (AltrX cross-linked polyethylene, DePuy Synthes) was placed. A trial reduction was then performed using a 36 mm + 5 femoral head, which showed good joint stability. Following this, a new sleeve was placed over the femoral taper, and a definitive 36 mm BIOLOX delta ceramic femoral head (CeramTec, Phlochingen, Germany) + 5 mm neck length was implanted. The wound was irrigated copiously and closed in layers with absorbable sutures, except for the cutaneous staples. An aseptic dressing was applied.

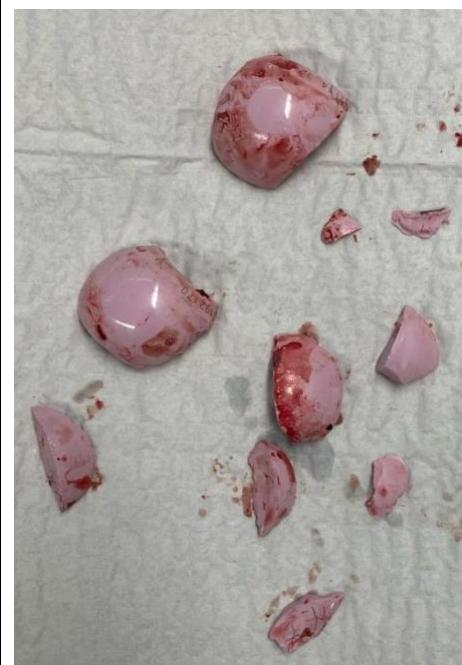
**Figure 4:** Clinical photo showing the broken fragments of the failed ceramic head.

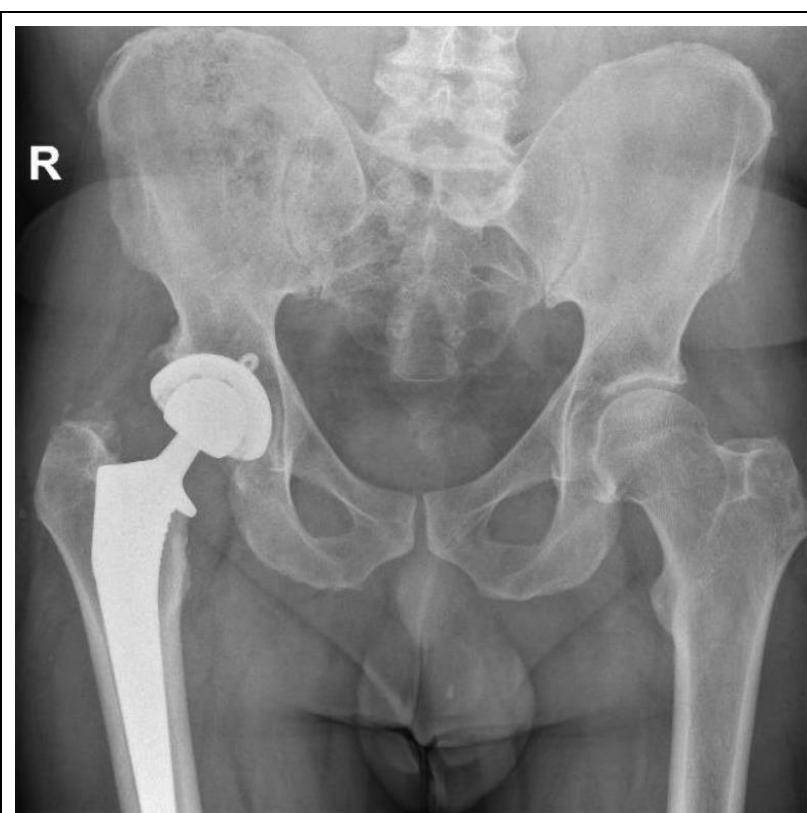
**Figure 5:** Post-operative X-ray showing good position of the revised THR.

The postoperative management included adequate pain relief and Clexane 60sc once daily over the course of 10 days. Full weight-bearing and mobilisation of the hip joint was permitted immediately. A follow-up radiograph of the patient's pelvis was performed, one day postoperatively, which showed a normal prosthesis alignment and minimal subcutaneous emphysema. Follow-up visits were scheduled at two weeks and three months, showing an uneventful recovery. Further follow-up visits were only necessary if clinically indicated.
